FITNESS FOR SERVICE BROCHURE – PART 1- DETERMINISTIC APPROACH

THE DETERMINISTIC APPROACH

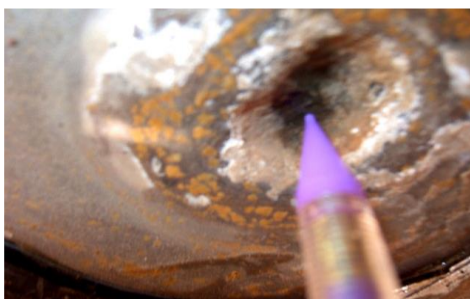
Figure 1 Typical External Corrosion feature on a high pressure steel pipeline
